## Marine F-4 Phantom crash at NAS Barbers Point Hawaii

By David Trojan, Aviation Archaeologist, [davidtrojan@earthlink.net](mailto:davidtrojan@earthlink.net) Nov2017

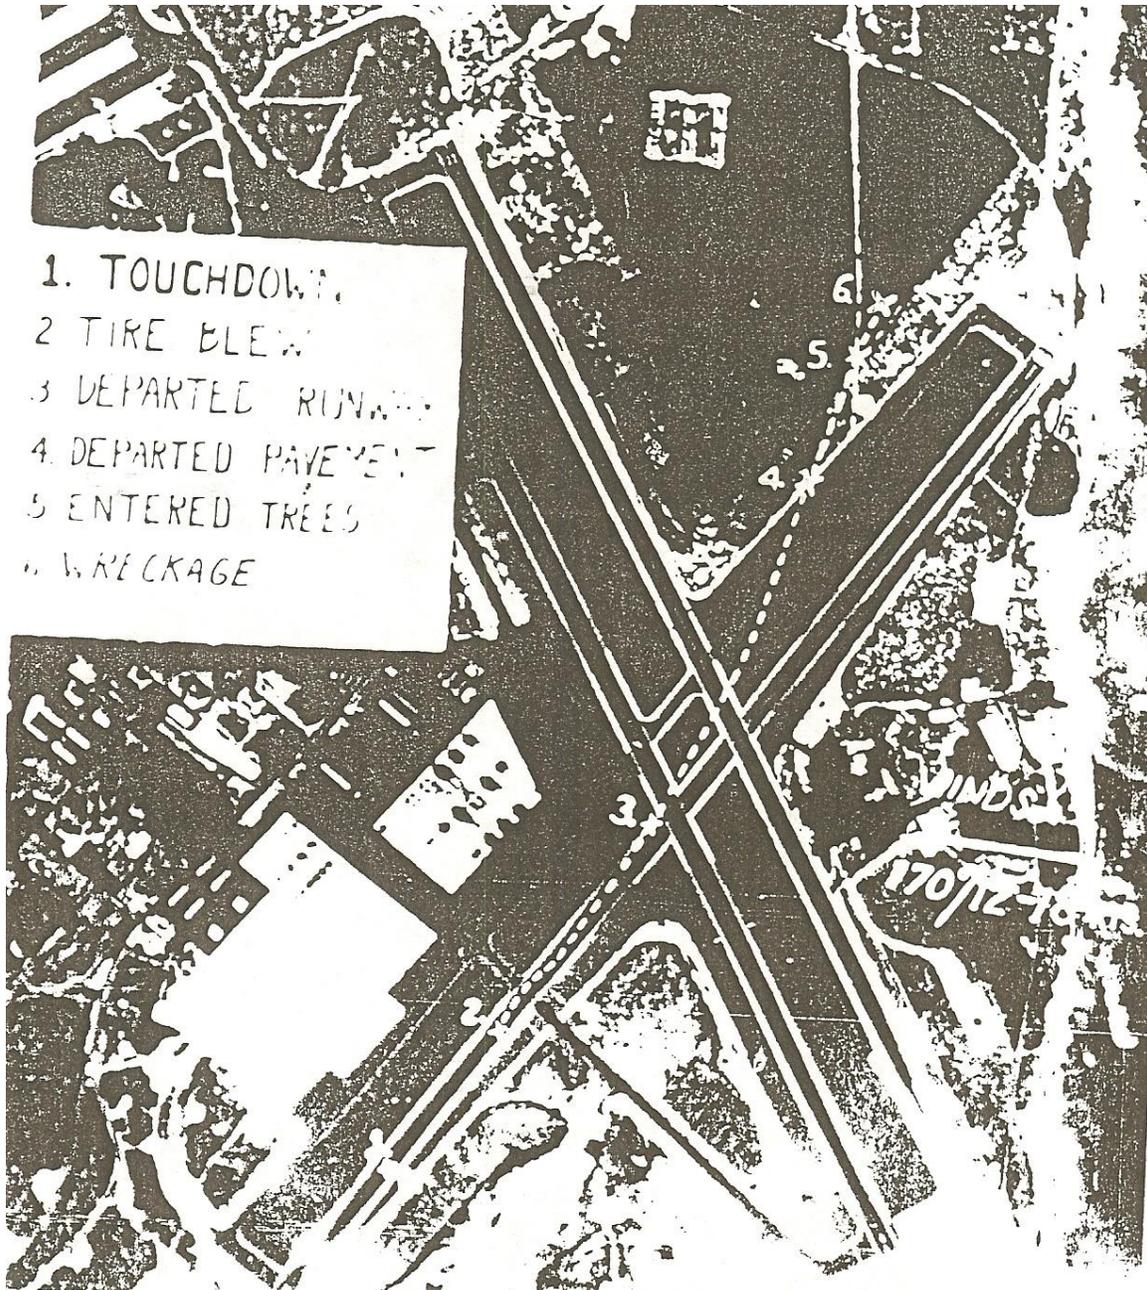
Wet runway conditions intensified directional control problems for WD-38. While countering these difficulties the left tire blew approximately 2400 feet from the approach end of the runway during the landing rollout on the wet runway. The aircraft speed was approximately 90 knots when the tire blew. When the tire blew the nose of the aircraft was 11 feet right of the centerline. The aircraft then

swerved further to the left side, then veered left and continued left departing the runway 4100 feet from the approach end. As the aircraft departed the runway with an estimated airspeed of about 120 knots, afterburner was selected for a go around, however the drag chute was not jettisoned.

**Map from the official accident report shows sequence of events.**

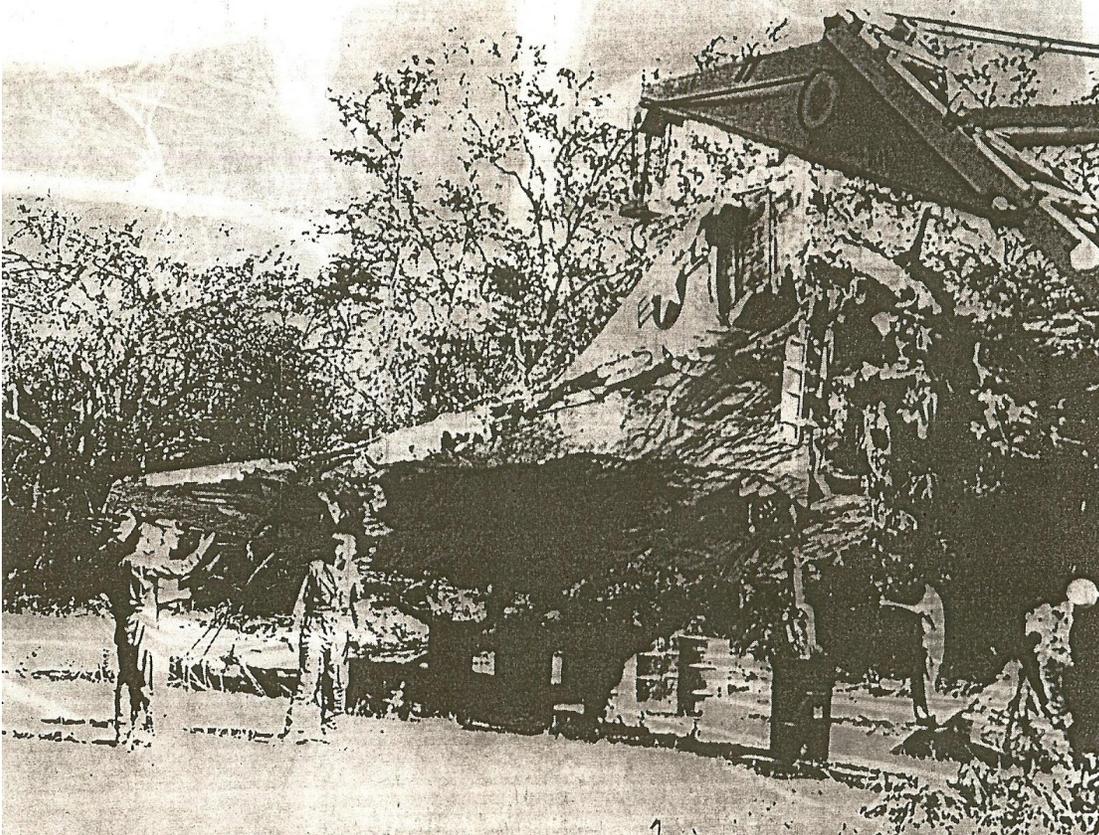
The forward part of aircraft was completely destroyed, including both cockpits. The aircraft center fuselage section and wings remained relatively intact. The tail section cracked in the area of fuselage fuel cell # 6. Post-accident investigation revealed that there was about 2000 pounds of JP-5 fuel aboard the aircraft and that this amount was more than sufficient for a wave-off and subsequent landing.

**The wreck of F-4J Phantom, BuNo153830 as it was pulled out of the trees and placed on 55 gallon drums, photo from the official accident report. It was reported that it remained there for years until it was finally scrapped at an unknown date**

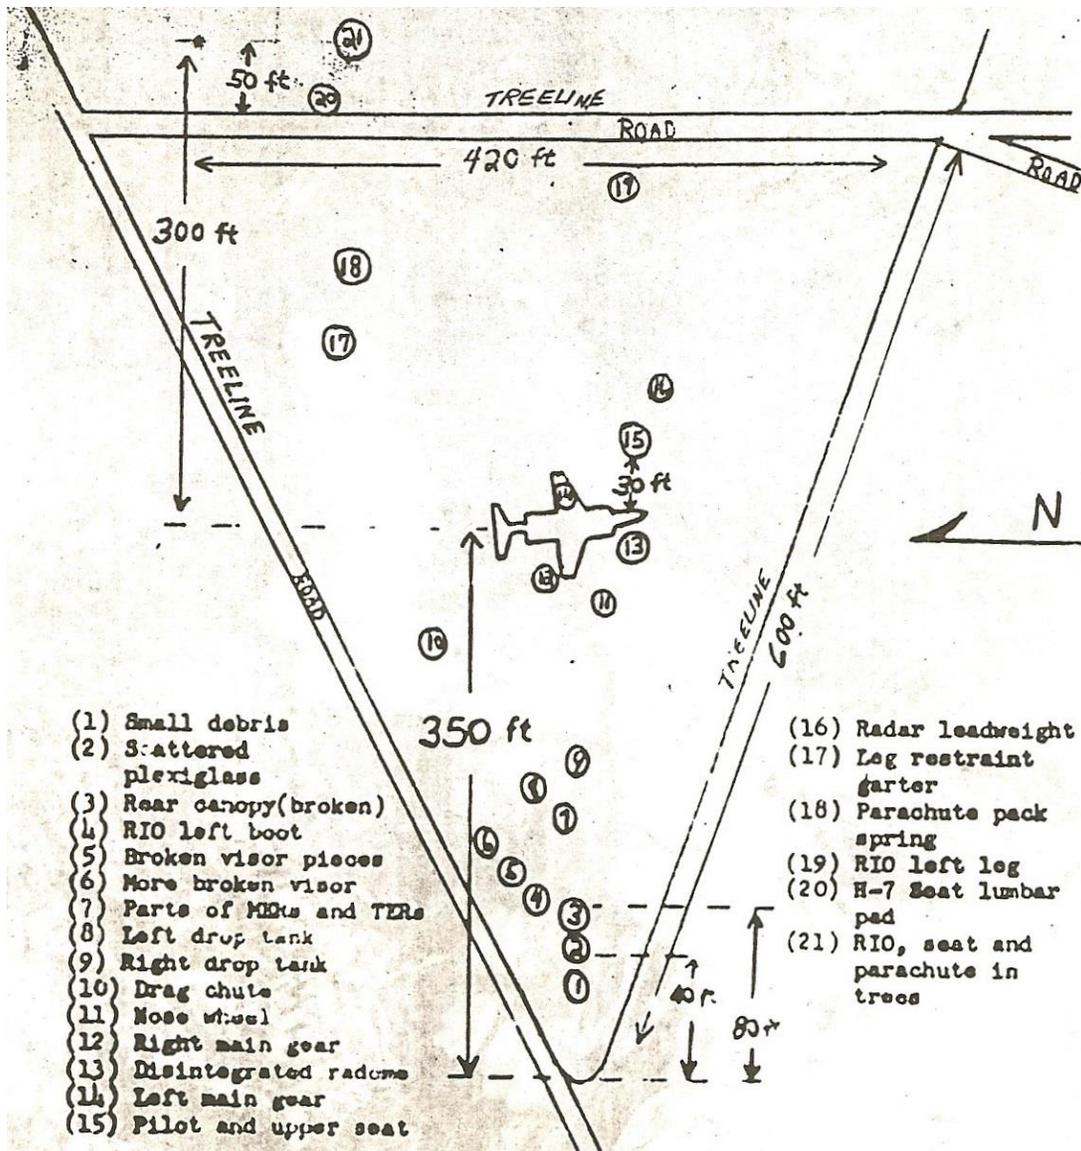
Both crew members were killed in the crash. The Pilot, Lt. E.D. Hughes made no apparent ejection attempt. The Pilot and the upper portion of his seat were thrown clear of wreckage on breakup. The Co-Pilot/RIO, Lt. P.S. Skaff attempted ejection, but was unsuccessful. His seat system appeared to have worked correctly, however the ejection did not start until after the aircraft had entered the wooded area. His seat traveled 50 to 300 feet above the 60 foot treetops. No parachute was observed in the air. The copilots' seat, parachute and occupant were found in a treetop approximately 100 yards east of aircraft. It was suspected that his seat and drogue chute had collided with the trees.

**Diagram from the official accident report shows aircraft debris pattern.**
